March 1991

By J. Kunsemiller

## Technical Note

## DEVELOPMENT OF A SEAWATER HYDRAULIC ROCK DRILL

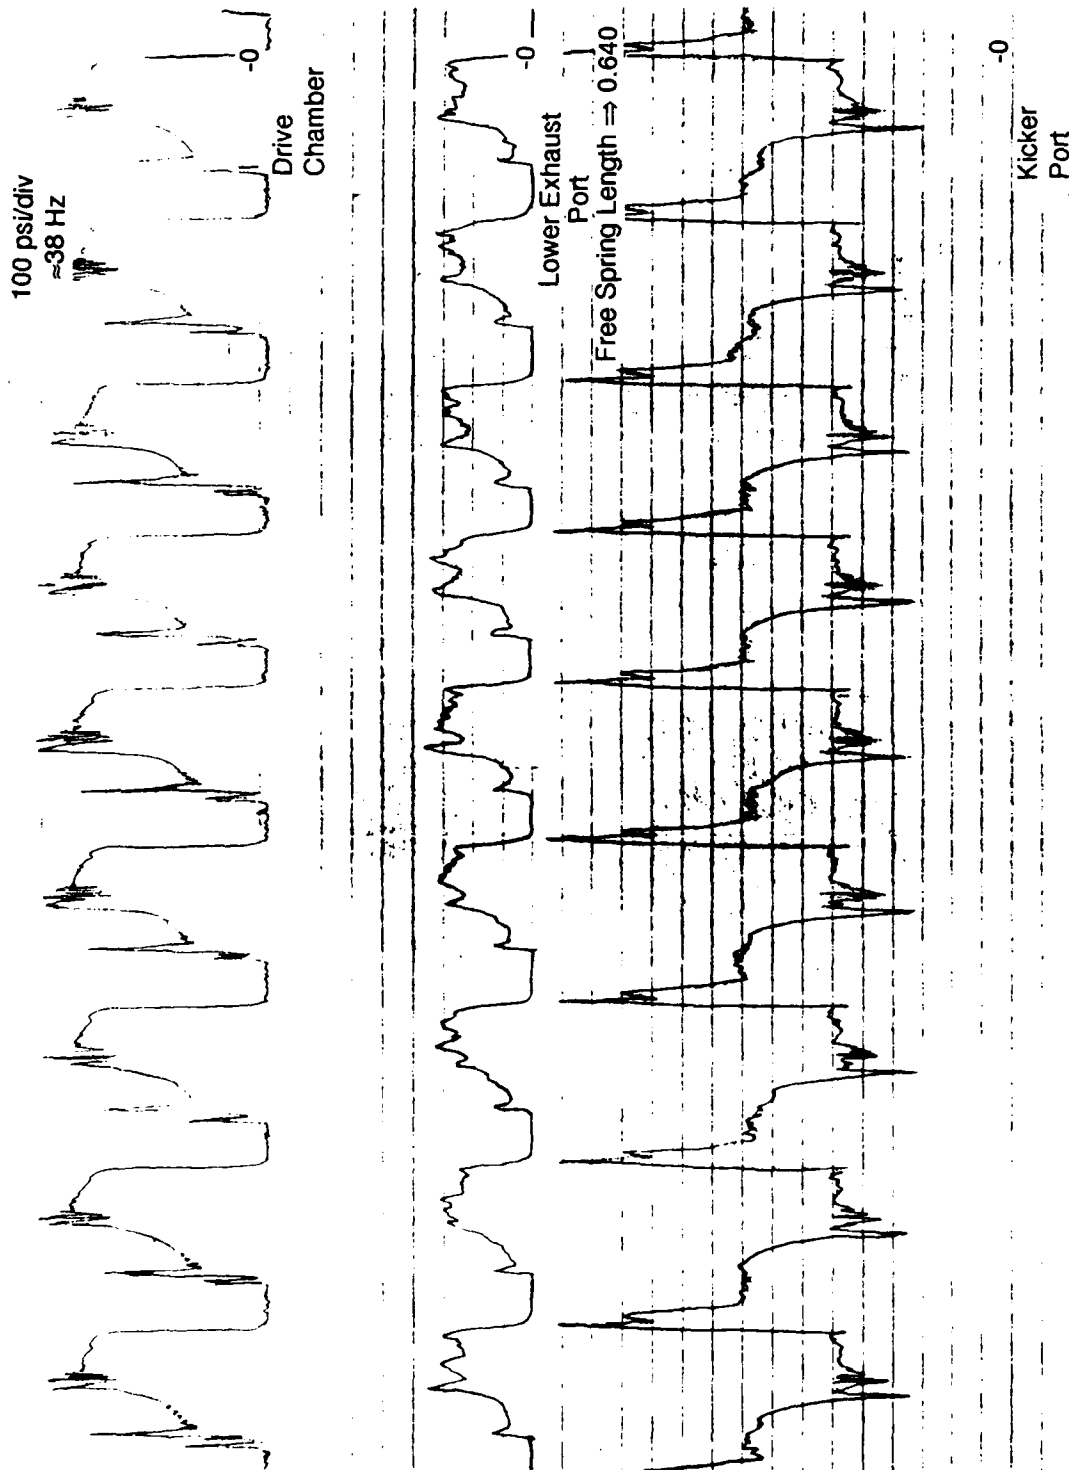
Figure 8. Exhaust pressure follows drive chamber pressure.

Further investigation with the ADM rock drill showed that the exhaust port pressure closely followed the drive chamber pressure (see Figure 8). This indicated that the exhaust poppet was not fully closing during the cycle. It was theorized that the combined affects of exhaust poppet leakage, drive plunger leakage, and parallel motor porting reduced the supply to the linear drive system. This would account for the low drive chamber pressure. To verify this, the motor supply was blocked so that the full supply flow of 13 gpm was directed to the linear system. As expected, the drive chamber pressure increased, as shown in Figure 9.

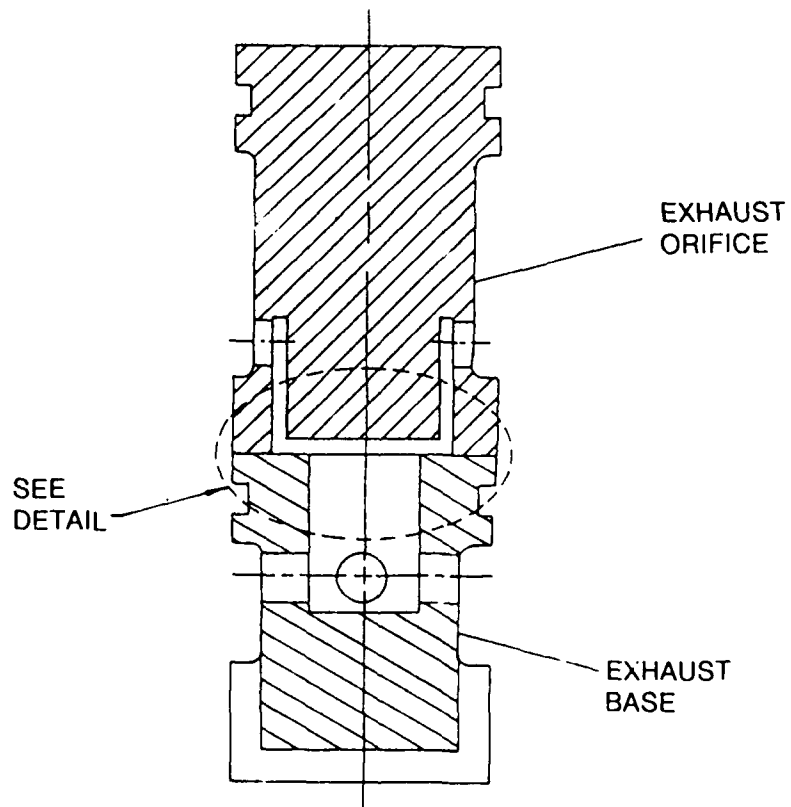
Figure 15. Exhaust orifice design.

The failure of the exhaust poppet to close, as encountered during the endurance test, did not affect cycle timing. The apparent effect of the open exhaust poppet was a reduced drive chamber pressure. This resulted in a small reduction in impact energy. It was theorized that the linear impact mechanism could be simplified by replacing the exhaust poppet with an orifice. Tests were conducted with an adjustable orifice to determine an optimum orifice size that would produce a minimal decrease in drill performance. Parametric tests determined the optimum opening and a fixed insert having this configuration was made to replace the poppet assembly (see Figure 15). This simplified cycle is referred to as a single poppet-kicker port cycle.

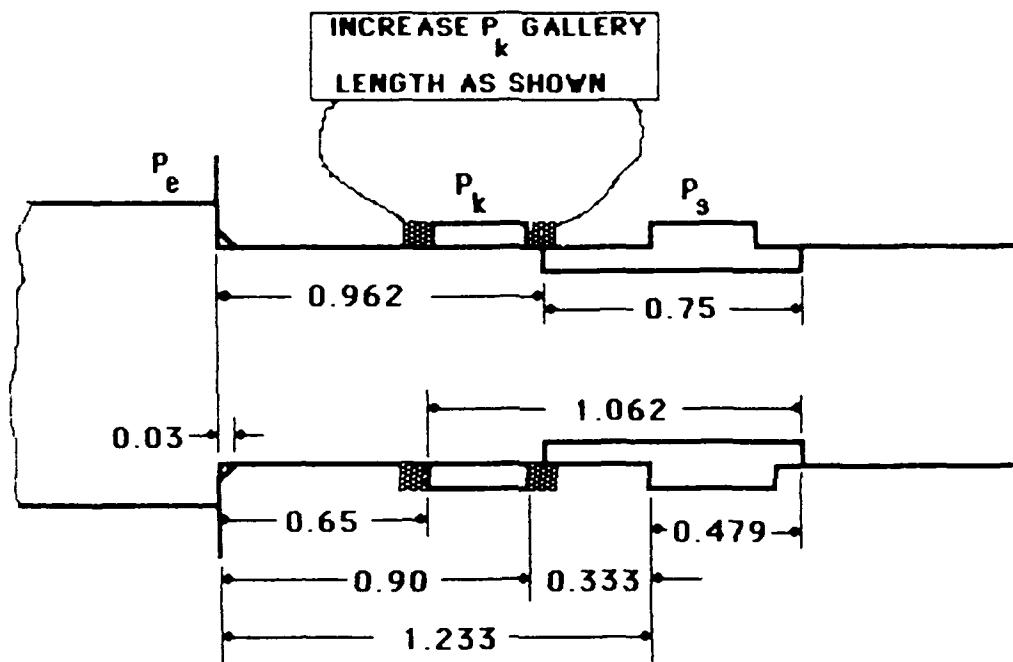
CRITICAL DIMENSIONS OF PLUNGER - SLEEVE  
ASSEMBLY. PLUNGER FULL FORWARD POSITION.

EXTENDING SLOT LENGTH IN SHADED AREA ON LEFT ALLOWS  $P_k$  COMMUNICATION WITH  $P_e$  AS PLUNGER APPROACHES FULL STROKE POSITION. THIS GUARANTEES THAT THE SUPPLY POPPET OPENS FULLY TO ESTABLISH THE DRIVE STROKE.

IN POSITION SHOWN  $P_s$  DOES NOT COMMUNICATE WITH  $P_k$ . THIS WILL LEAD TO CAVITATION IN THE SUPPLY POPPET GALLERY BECAUSE THE POPPET IS CLOSING AND REQUIRES A CONTINUOUS SUPPLY OF FLUID UNTIL IT IS SEATED.
